Manhole Inspection Summary

Manhole # S27E__036MH

Insp Date: **5/16/08 10:46 AM**

Location Address: **115 N Fremont**

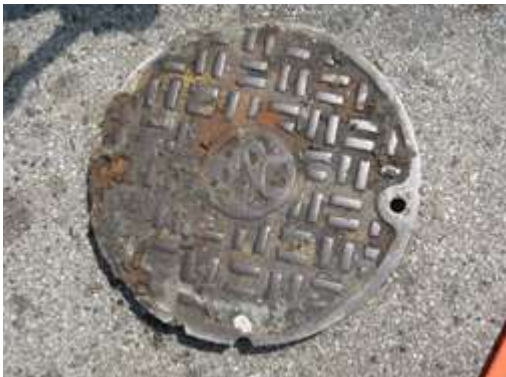
Defect 4

Type: **Sanitary** Condition: **Worn** Cover Material: **Cast Iron**

worn lid

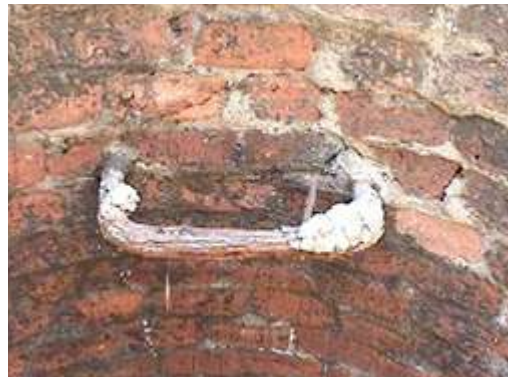
Defect 3

Steps Count: **4** Missing: **0** ☒ **Corroded**

corroded rungs

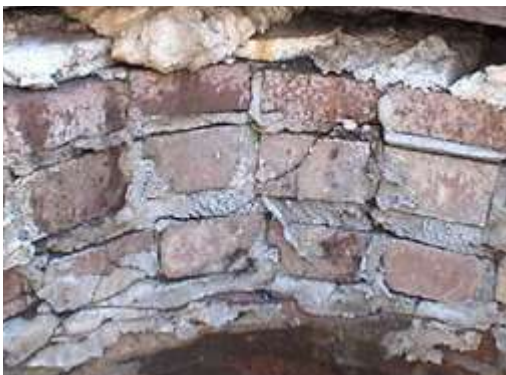
Defect 2

Condition: ☐ Sound ☒ **Cracked** ☐ Root Intrusion ☒ **Loose Brick** ☐ Deteriorated

Infiltration: ☐ None ☐ Joint ☒ **Cracks** ☒ **Mortar** ☐ Roots ☐ Wall

cracked & loose bricks with infiltration from mortar & cracks

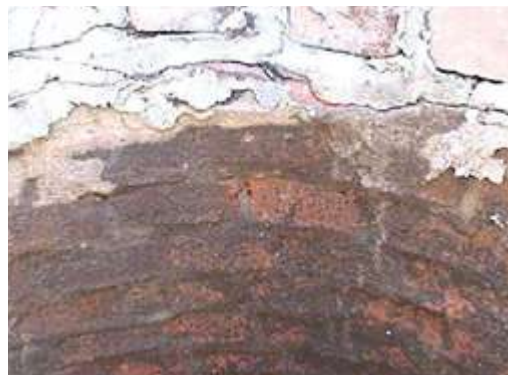
Defect 1

Frame Offset: **0** (in.) Condition: ☐ Sound ☐ Cracked ☒ **Leaks**

infiltration lid as well

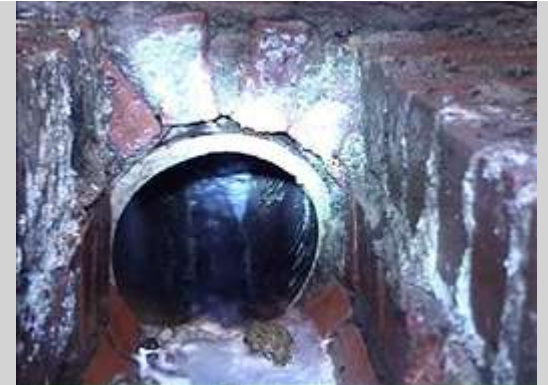
12 O'Clock Outflow

Pipe Height: **8.4** (in.) Rod and Bar (Angled)
Pipe Material: **PVC** ☐ Pipe Lined
Invert Depth: **10.76** (ft.) Flow Characteristics: **Fast**
Deposits: ☒ None ☐ Mud ☐ Sludge ☐ Debris ☐ Grease
Silt Depth: **0** (in.) Deposits Extent:
Infiltration: **None** Pipe Seal Cond: **Sound**

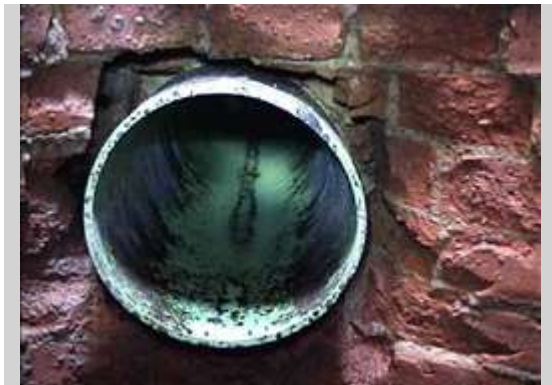
6 O'Clock Inflow

Pipe Height: **8.4** (in.) Rod and Bar (Angled)
Pipe Material: **PVC** ☐ Pipe Lined
Invert Depth: **7.20** (ft.) Flow Characteristics: **Slow**
Deposits: ☒ None ☐ Mud ☐ Sludge ☐ Debris ☐ Grease
Silt Depth: **0** (in.) Deposits Extent:
Infiltration: **None** Pipe Seal Cond: **Sound**

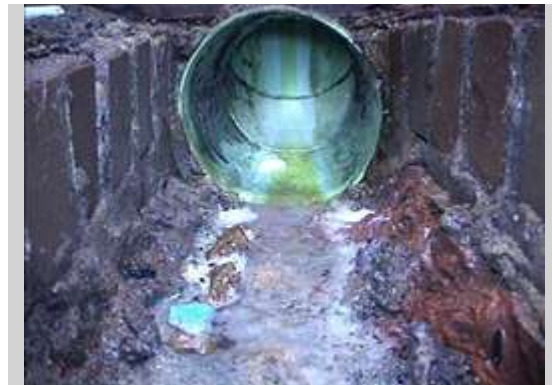
Drop In @ 6 O'Clock

Drop: **Outside** Rod and Bar
Angled: **Yes** Reading: **9.20** (ft.)
Inv Depth: **10.20** (ft.)
Drop Condition: **Open**
